HOUSE OF REPRESENTATIVES

(REPORT BY MR. J. O'DEA UPON THE VENTILATION OF THE).

Mr. J. O'DEA to the Hon. the MINISTER for PUBLIC WORKS.

Sir,— Evening Post Chambers, Harbour Street, Wellington, 25th March, 1893.

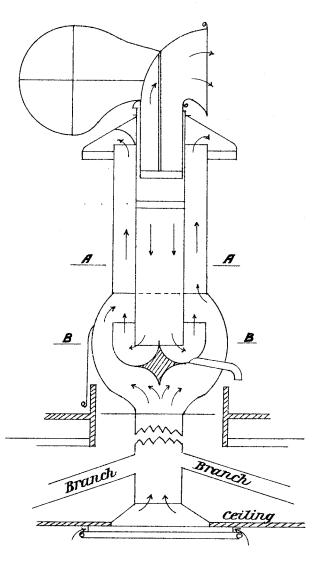
___<u>Section of Cowl</u> __

2. The ventilation on the roofs and ceilings is by no means sufficient to pump out the air from within the House, and as a consequence it must escape through doorways when others are opened in opposite directions: this of course causes draughts, and can be remedied only by sufficient ventilation in the roofs and ceilings without causing a down-current. I enclose plan of ventilator which I would recommend to be fixed on the roofs and ceilings in place of those already on, which are quite useless, as they had to be closed on account of the down-draught which they cause. This ventilator which I recommend is constructed on the siphon principle, and is superior to any of the latest improvements, and moreover I would be pleased to make a practical test for you when convenient, as I have had a model made specially for that purpose. I would recommend two of this plan to be fixed on the roof over chamber, six in the lobbies to the right of the chamber leading to the galleries, and two with branches over the strangers' gallery, and landing outside the reporters' gallery.
