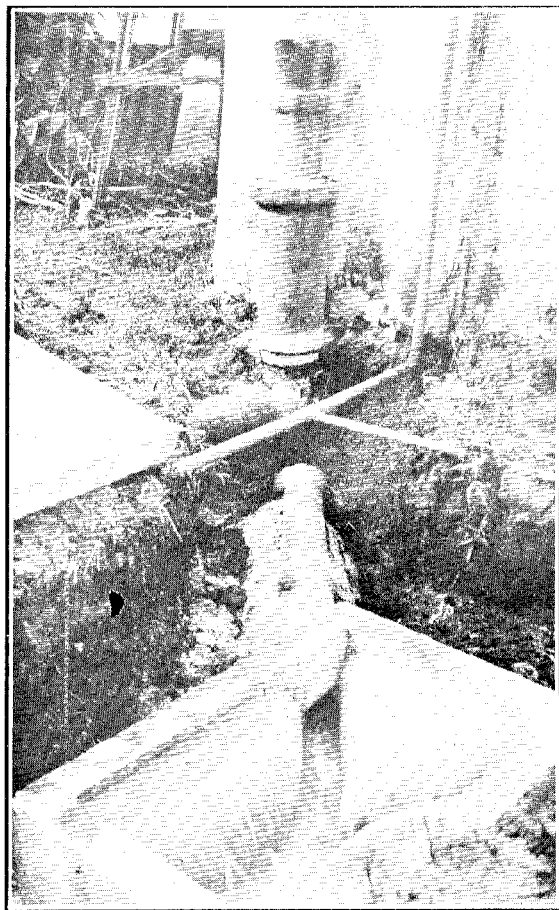
FIG. 3. Old drainage, with new system being installed. Note the 4 in. earthenware pipe, then a 6 in., and finally a 4 in. pipe with 90 per cent. bend. Earthenware instead of cast iron. No terminal vent. No anti siphon vent.
