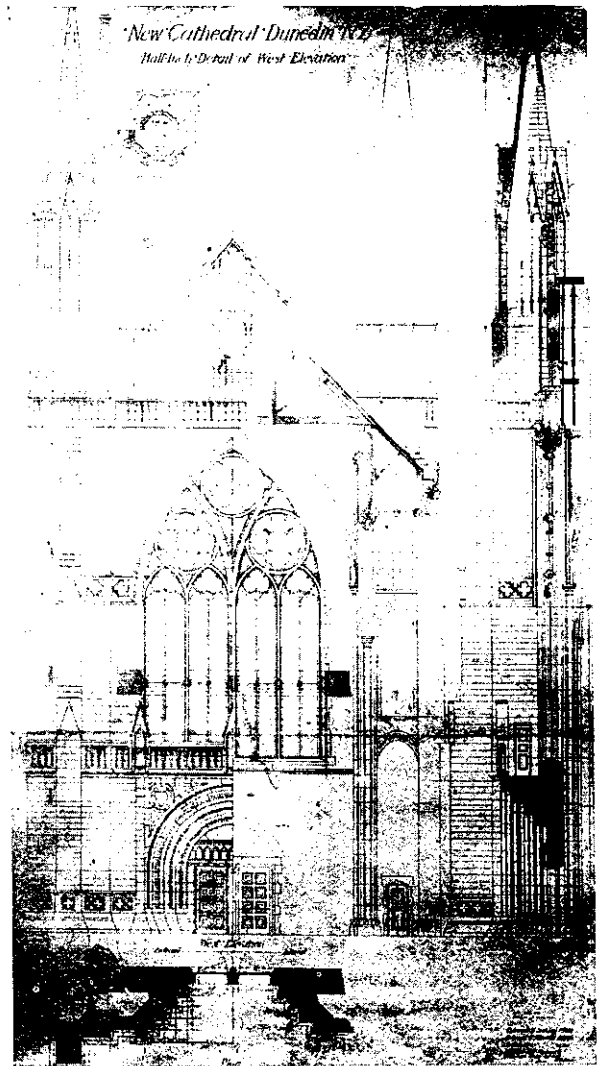
DETAIL OF FRONT

This illustration shows the centre portion including the turrets, but omits the West end of aisles.
