NEW ZEALAND HARBOURS

SKETCH COPY OF PLAN REFERRED TO IN REPORT

GREYMOUTH

DRAWING N^o 3.

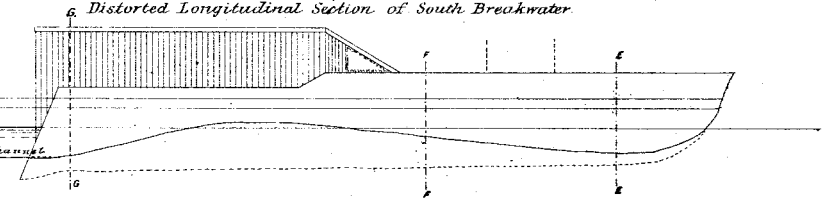
Fig 13.
Elevation of staging for Outer Works.
North & South Breakwaters.

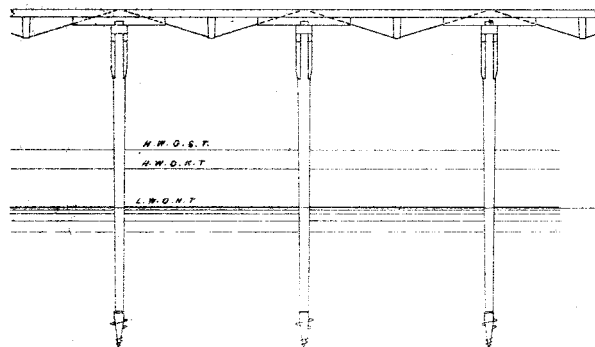
Fig 12.
Cross Section of staging for Outer Works.
North & South Breakwaters

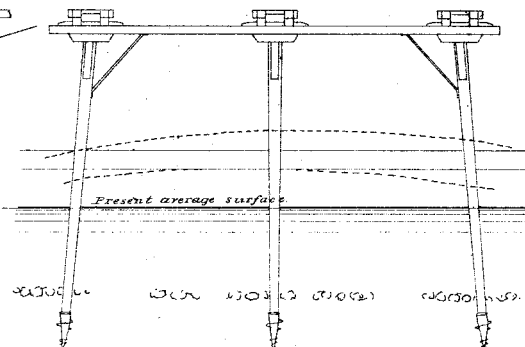
Fig 11.
Cross Section of South Breakwater
on line G.G. Fig 8.
