# SOLDIERS AND WAR MEMORIALS

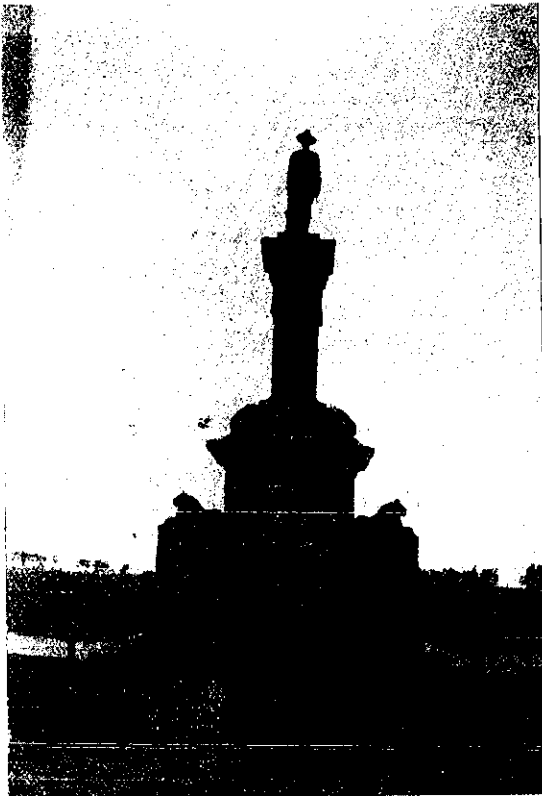
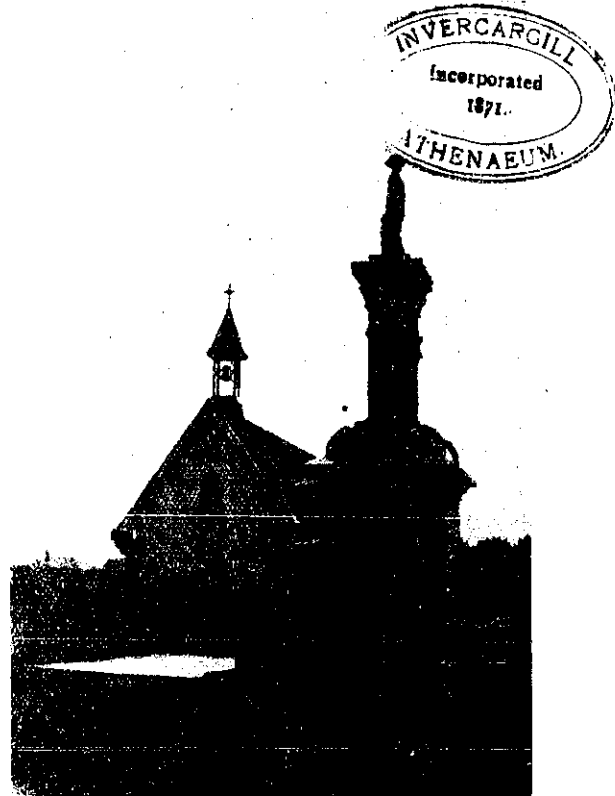
Two Views of Concrete Monuments erected in Southland

The memorial, including the figure of the soldier, is made of concrete, and, as will be seen from the photographs, is lacking in good proportion.

pendent upon the comparative relations of various dimensions. The memorial is weak in the matter of proportion, and the map or outline is very unsatisfactory.

Different materials have different peculiarities, and the mark of good art is to adapt the subject to the material. Concrete is not a suitable material in which to carve a figure. In the pedestal, the strong contrast produced between the cement and the marble is not pleasing to the eye. The base, the pedestal and the figure should have been united in such a way as to form a definite whole. The cornice or cap is much too heavy, and thereby disconnects the figure and the pedestal. The strength of the shade and shadow caused by the heavy cornice is
