## Summary of carving restoration programme

Following is a summary of the procedure taken in the restoration of the carvings as recommended by Mr Karel Peters.

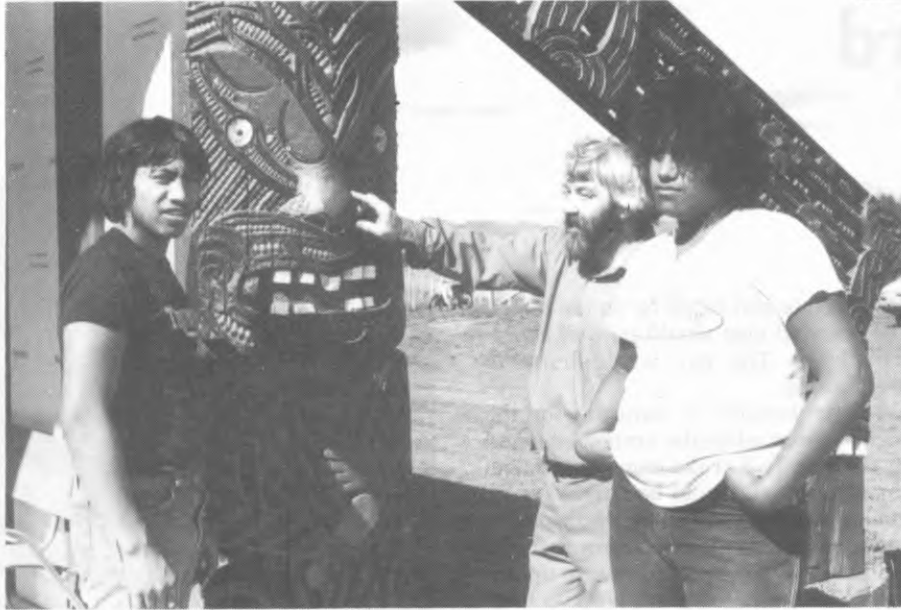
Karel Peters (2nd from right) with local Maori youth who worked on the restoration.
